PHOTOGRAPHIC INTELLIGENCE REPORT

CHU-HSIEN AREA MILITARY FACILITIES

CHU-HSIEN, CHINA

DATE APRIL 1967

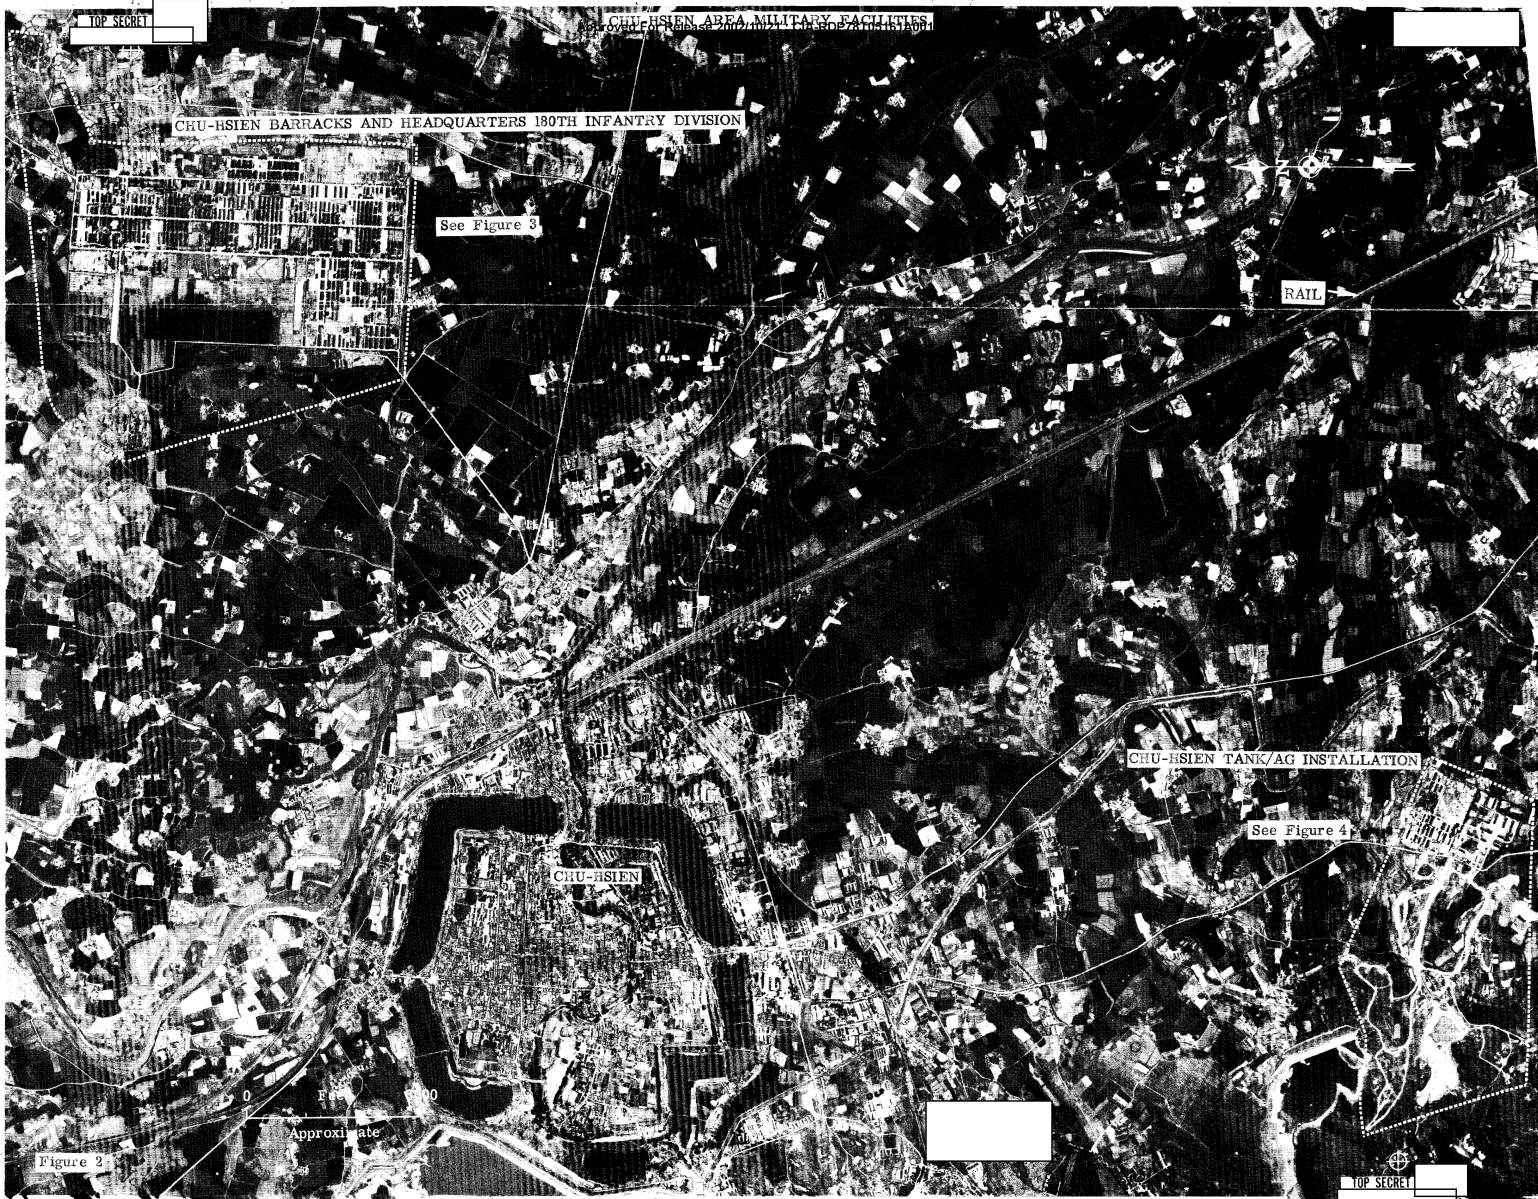
This road-served secured military installation, located 1.6 nm NE of Chu-hsien, houses a probable infantry division and associated support units. Comparative photography reveals no significant change in facilities [REDACTED] with the exception of some new animal pens in Area E which were built sometime [REDACTED]. The installation appears to have a medium level of activity on all coverage.

This road-served tank/assault-gun installation, located 2.6 nm SSE of Chu-hsien, consists of a secured billeting area, a secured tank/assault-gun storage and maintenance facility, and a tank/assault-gun driver-training area and firing range. No apparent changes in facilities are observed [REDACTED]

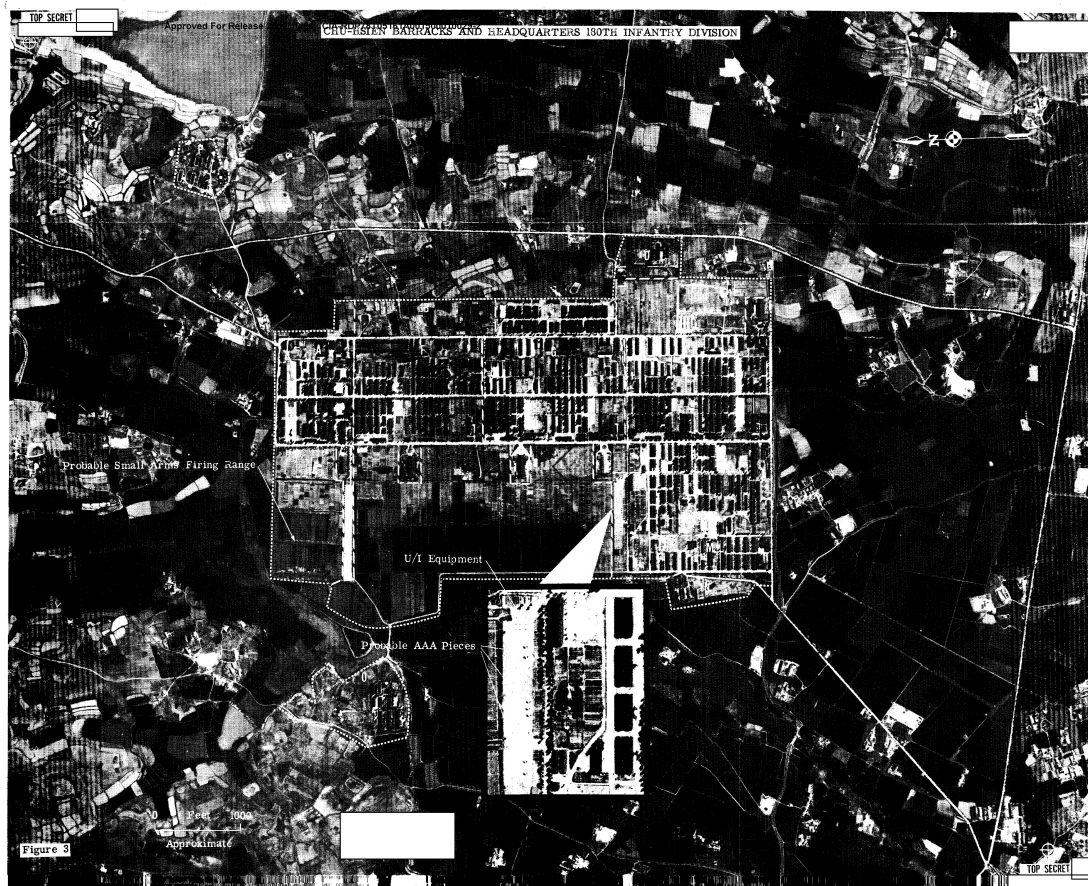
Seven probable AAA pieces and 9 U/I pieces of equipment are observed on [] coverage (see Figure 3).

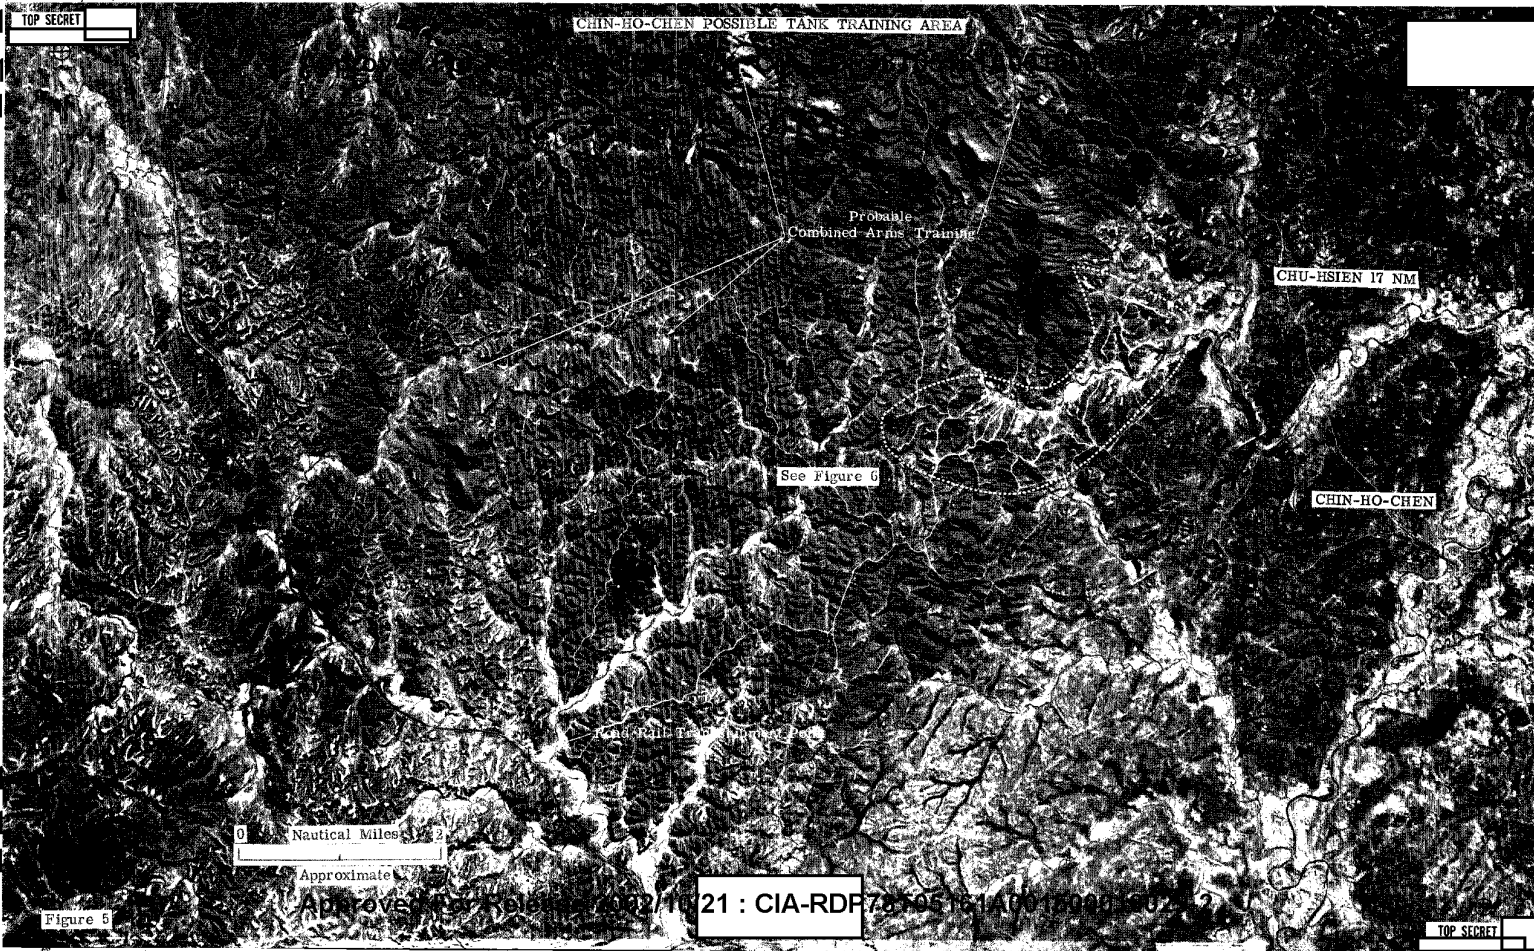
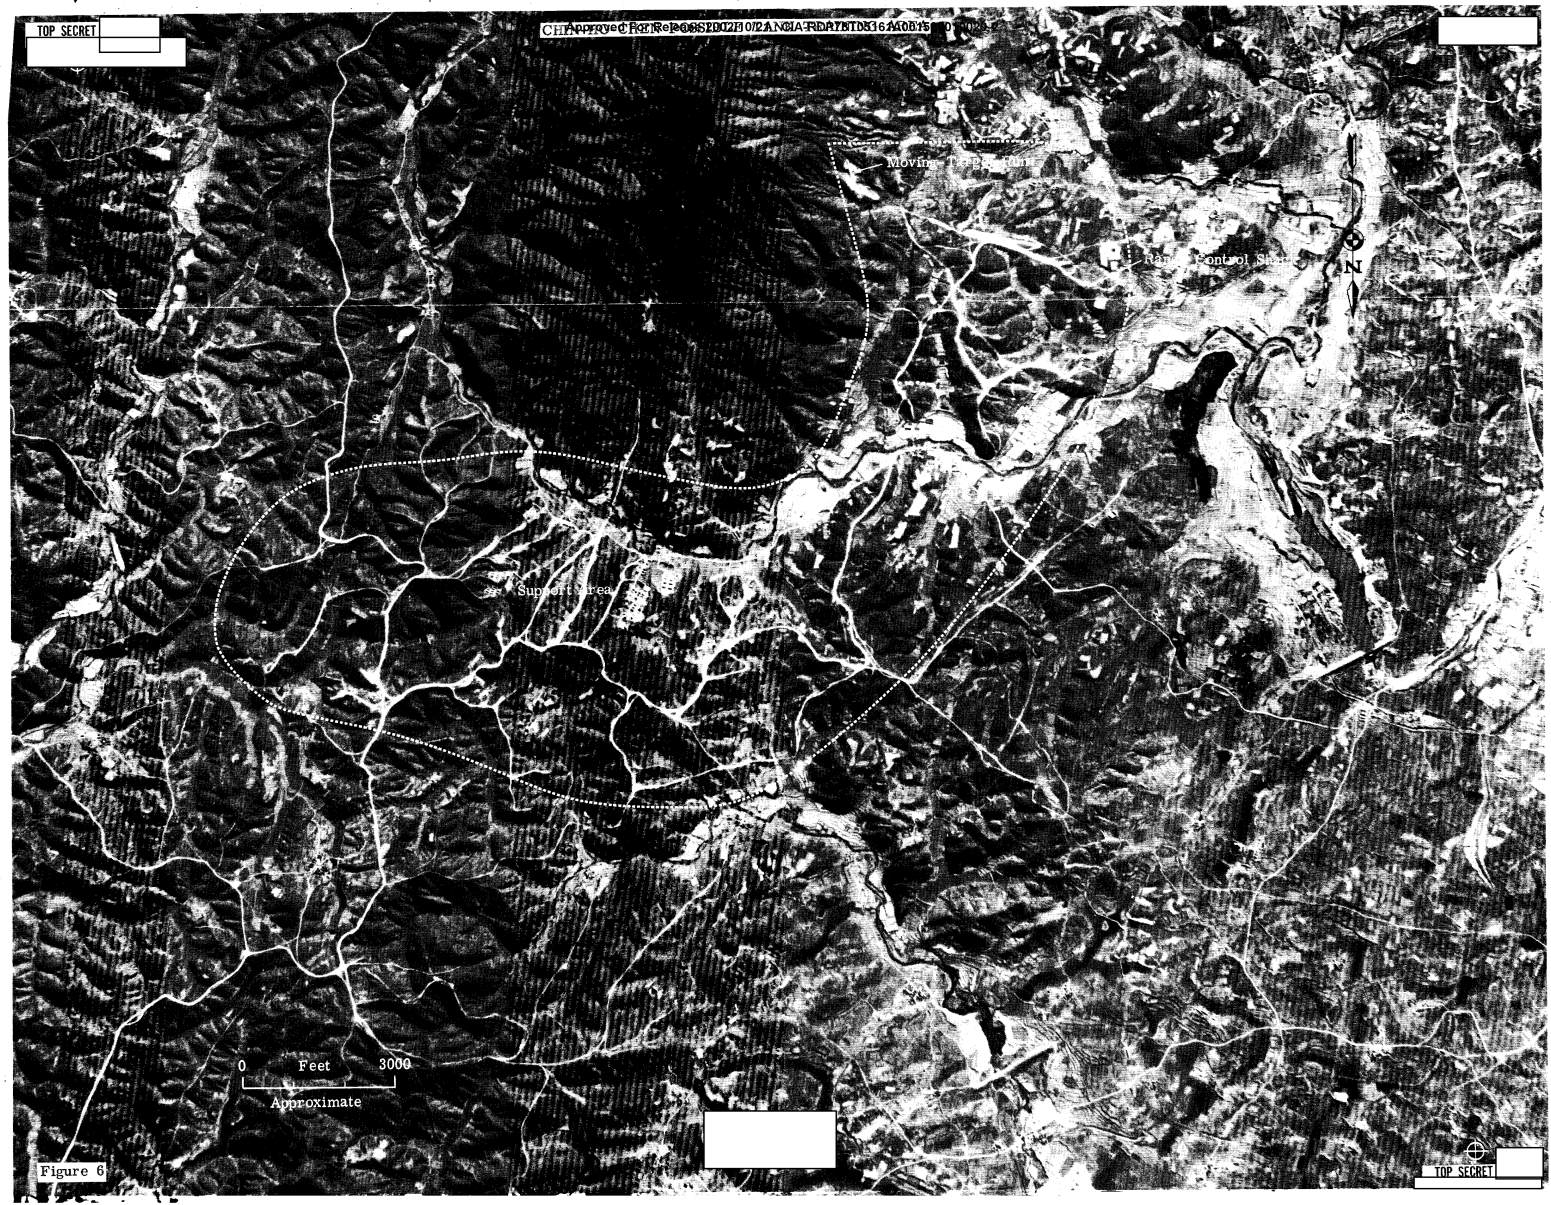
This installation, located 4.5 nm SE of Chin-ho-chen and 17 nm NW of Chu-hsien, consists of a possible tank/assault-gun moving-target firing range with 1 moving-target-run and a range control shack and a probable support area located 1.4 nm NE of the range containing approximately 70 buildings. The training area is connected by road to the Chu-hsien/Pang-fou rail line. Comparative coverage shows that construction of the probable support area occurred sometime
